TEST REPORT

Full scale bushfire deck test of Naxan decking boards in accordance with AS 1530.8.1-2007

EWFA Report No:

39104000.2

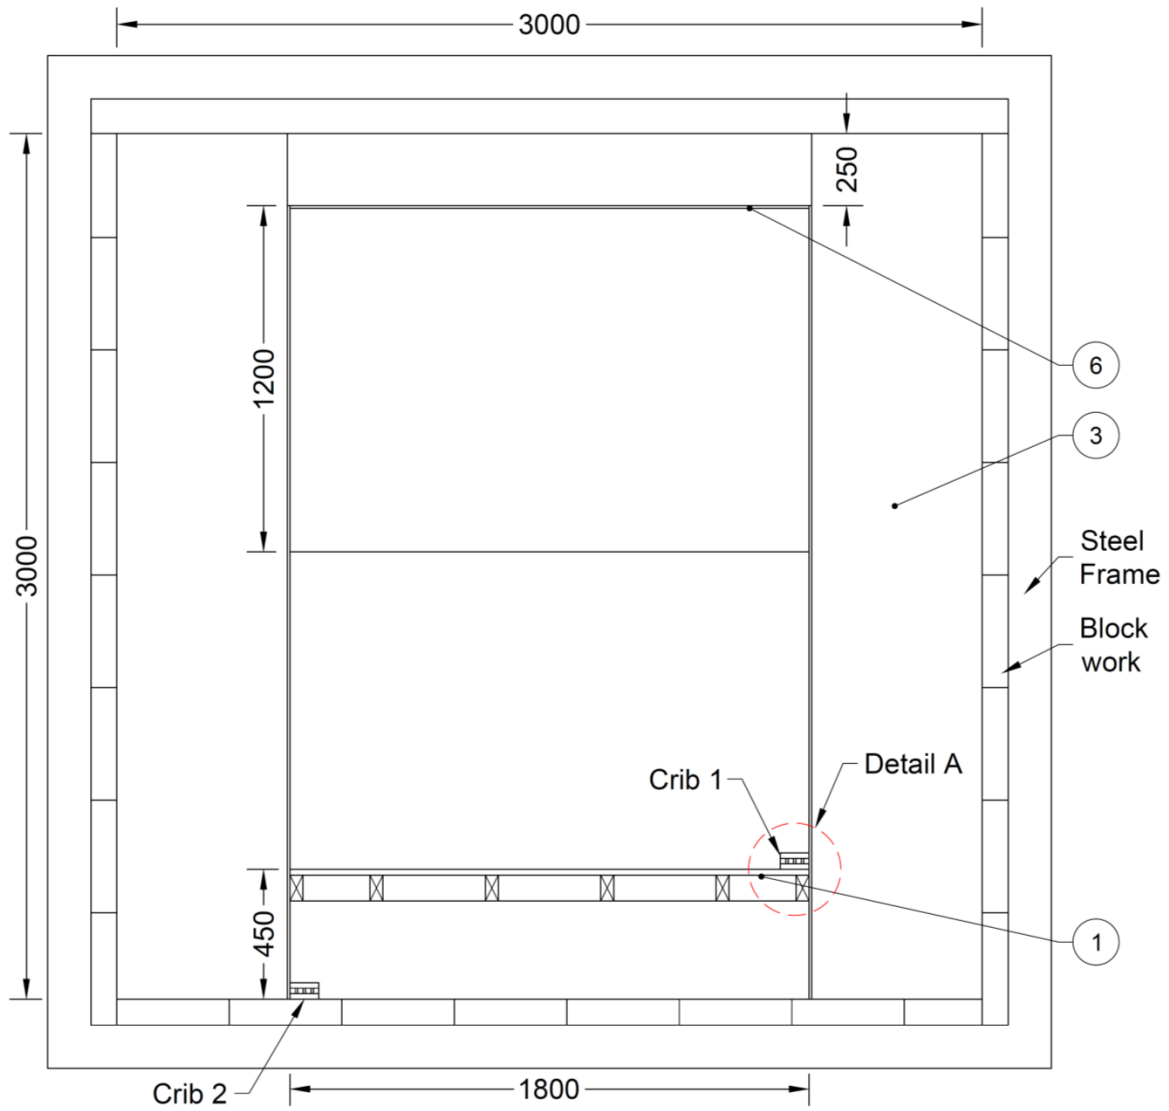
Figure A1.1: Exposed side elevation of test specimen

The test assembly comprised a nominal 1800mm wide x 750mm deep x 450mm high deck that was set within a 1800mm wide x 250mm deep recess formed within a nominal 3000mm x 3000mm wall system which met the minimum requirements as specified by AS3959 for the specified exposure level.

The deck consisted of Naxan decking boards that were 140mm wide x 25mm thick, that were installed parallel to the wall system with no spacing between each board. The boards were secured to joists with 6g x 35mm screws. The front fascia of the specimen consisted of 1-off decking board horizontally installed in the vertical plane.

The full description of the specimen is provided in Figures A1.1 to A1.4 and the 'Schedule of Components' in Section 2.

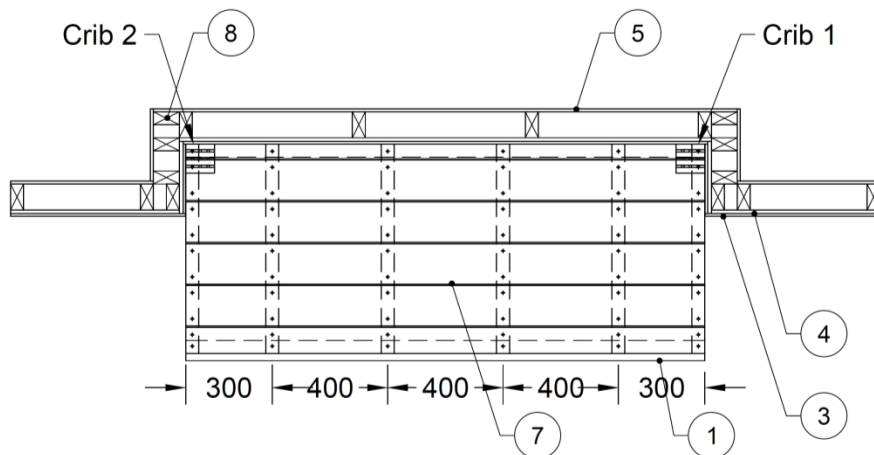
Figure A1.2: Horizontal section through test specimen

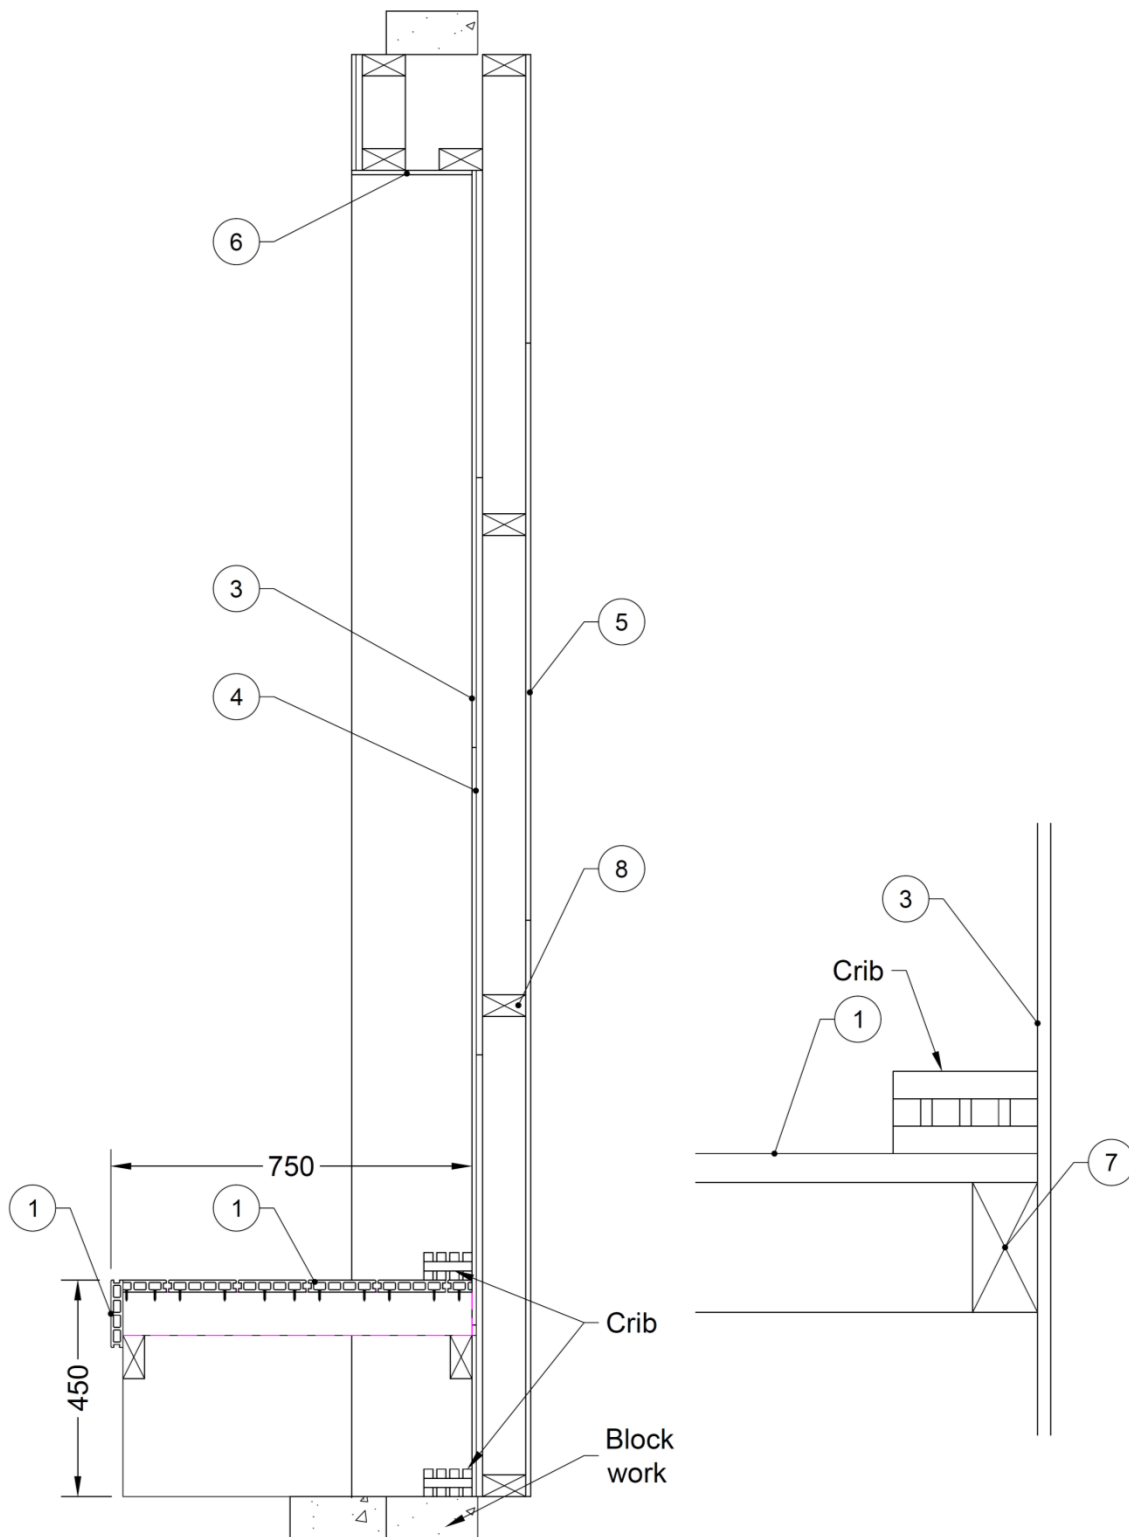
Figure A1.3: Vertical cross section through test specimen

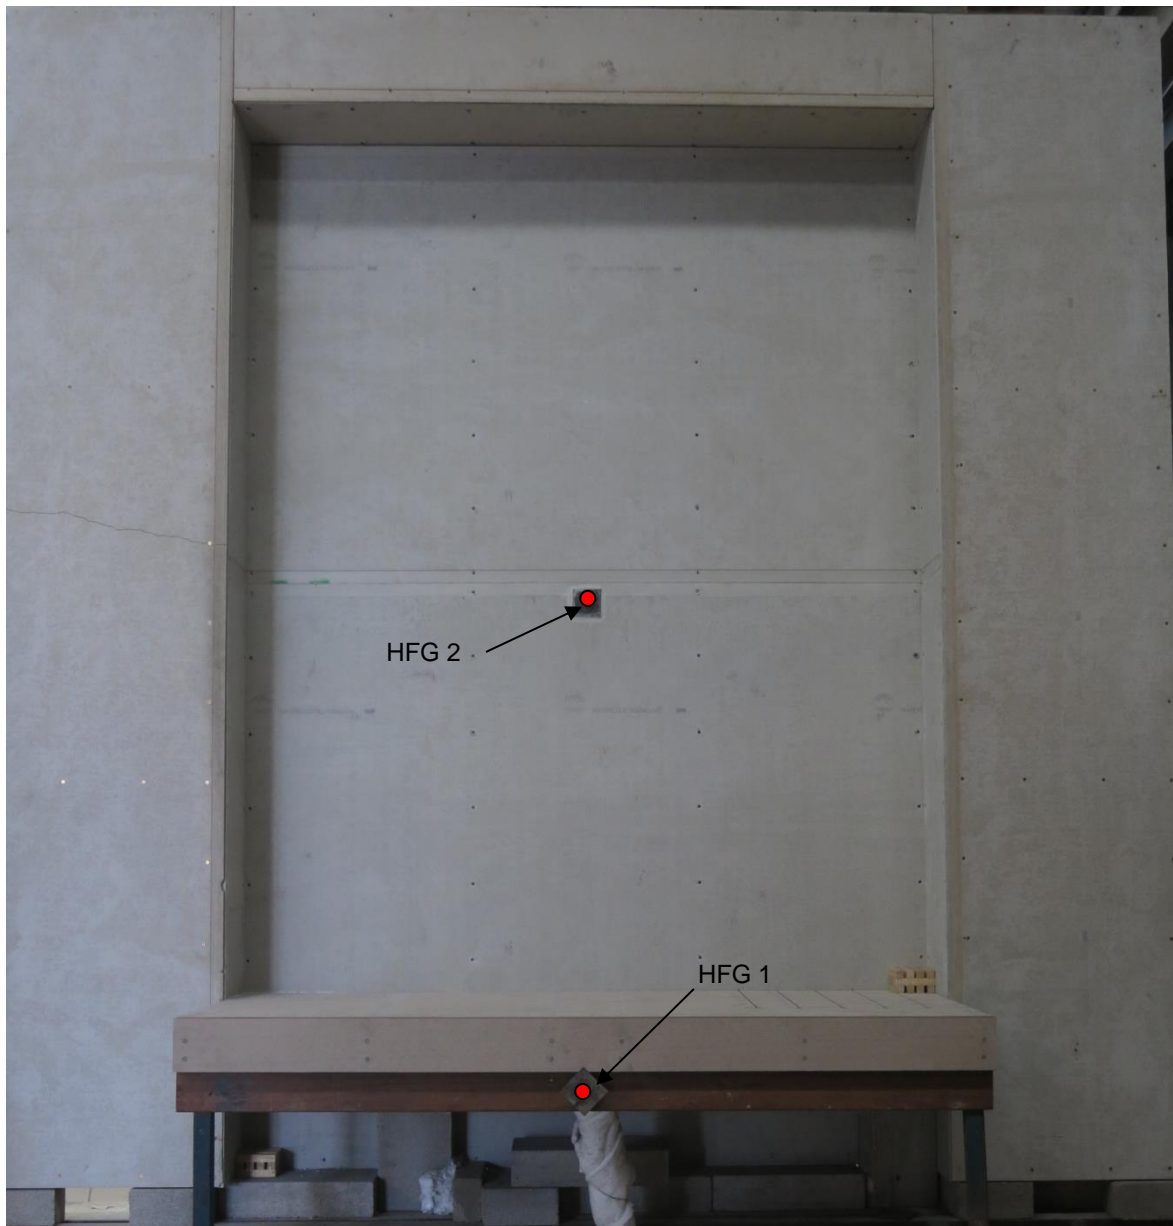
Figure A4.1: Heat Flux Gauge locations on exposed side
HFG 1 centrally located across the deck, nominal 50mm below the bottom of the deck.
HFG 2 located at the centre of the wall.

The radiation received at the front of the deck system was measured by a heat flux meter for the radiant exposure portion of this test. A second heat flux meter was placed in the centre of the wall to provide additional information. The heat flux meter positions are shown on Figure A4.1 in Appendix 4.

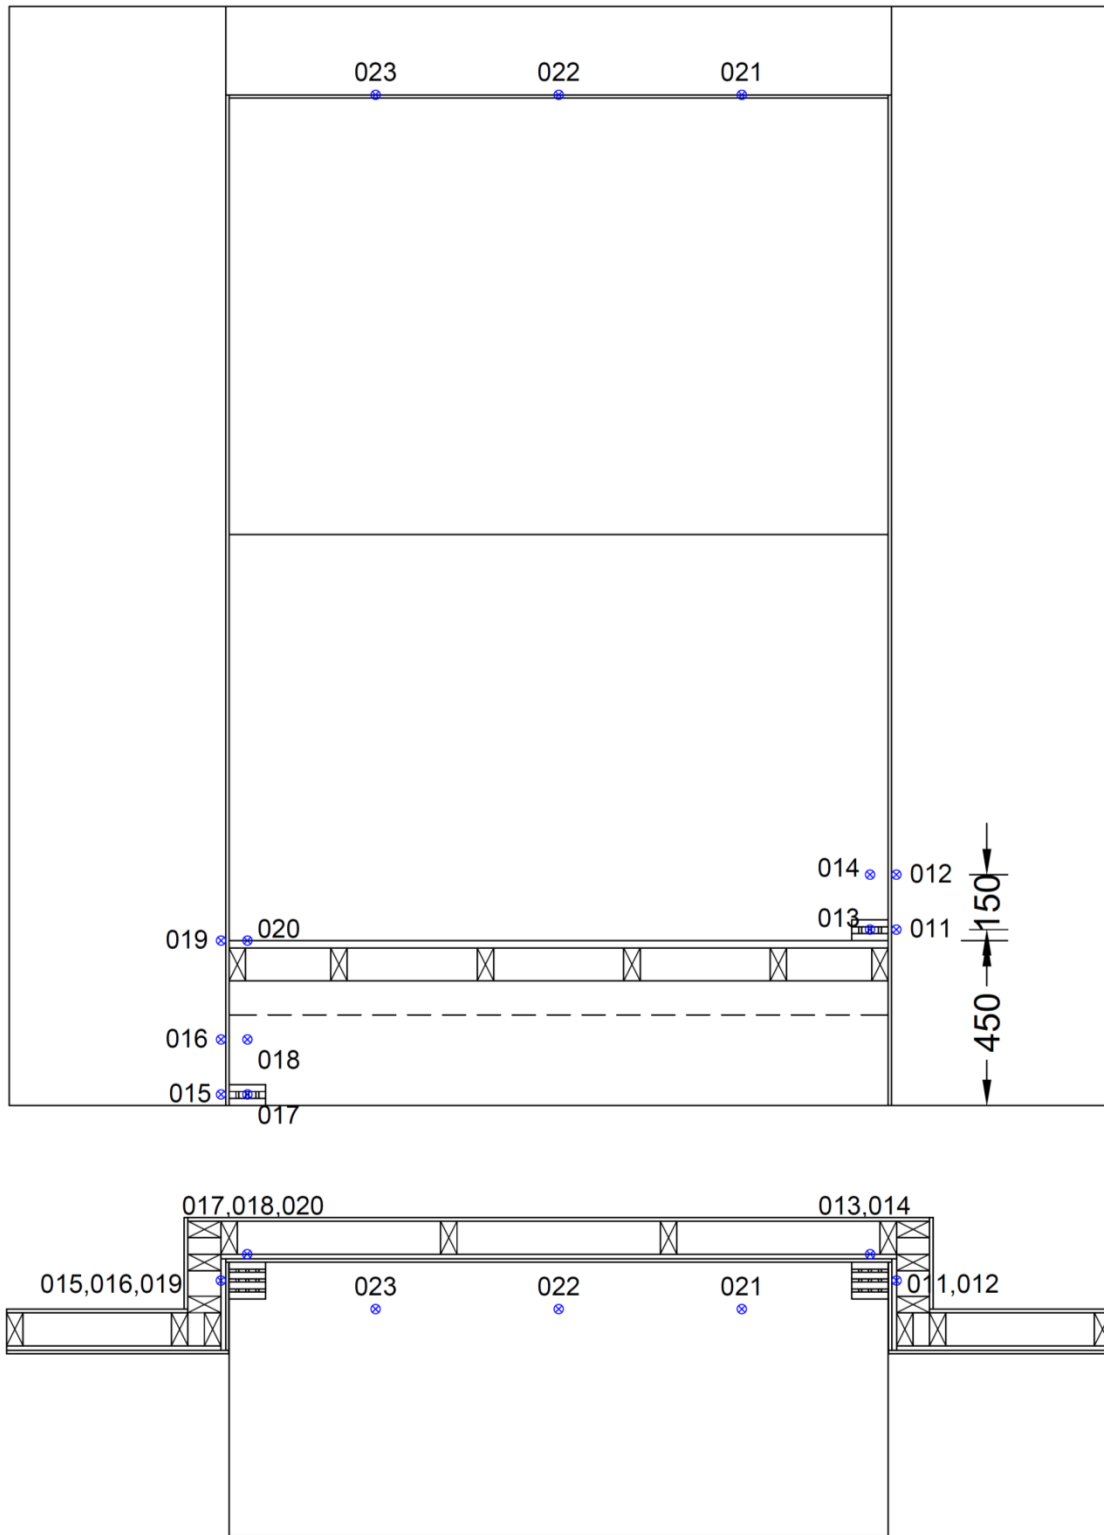
Figure A4.2: Thermocouple locations

The internal specimen temperatures were measured by Type K thermocouples with wire diameters less than 0.5 mm diameter soldered to 12 mm diameter x 0.2 mm thick copper discs covered by 30 mm x 30 mm x 2.0 mm inorganic insulating pads. The thermocouples' positions are shown on Figure A4.2 in Appendix 4.

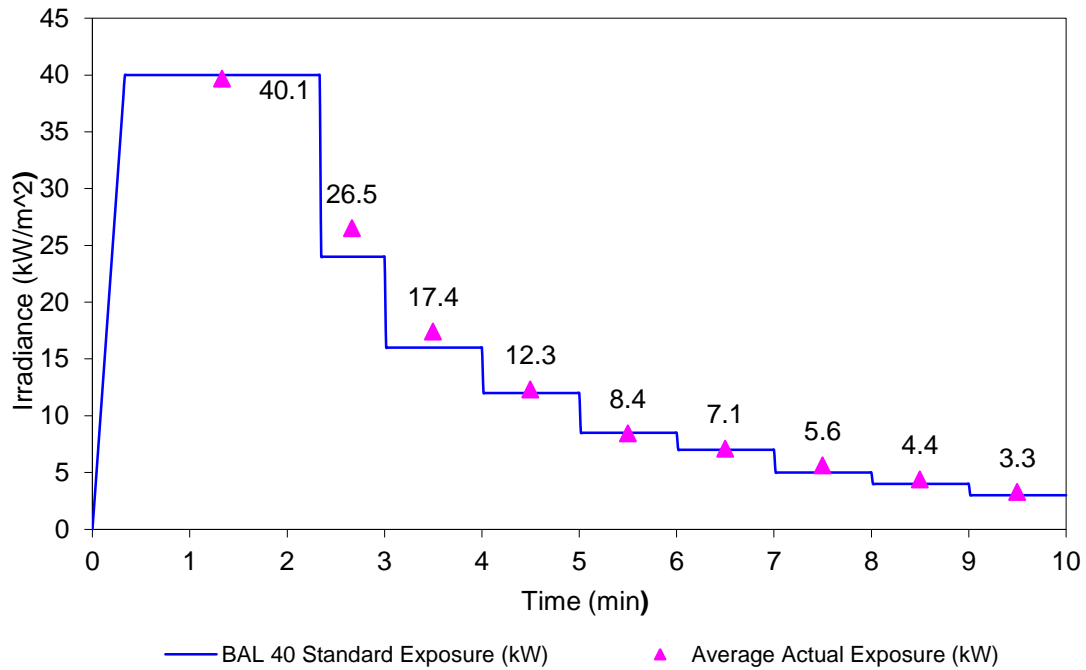
Figure A5.1: Irradiance levels received at the front of the decking system

Radiation data is provided in A 5.1 in Appendix 5.

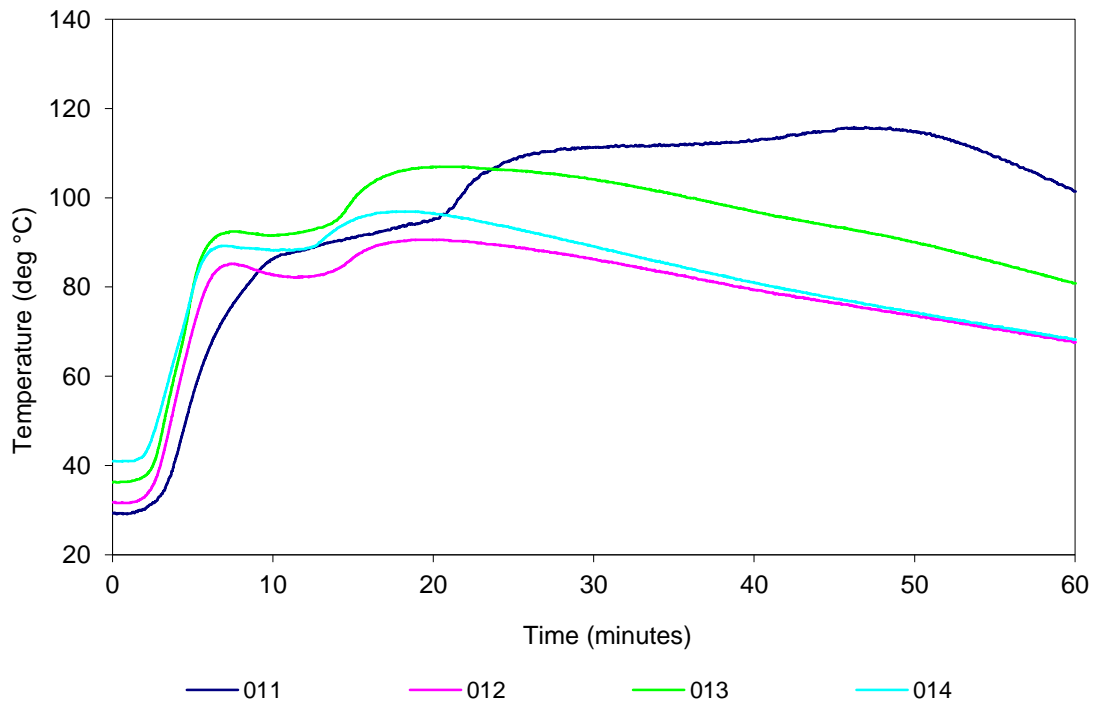
Figure A5.2: Top Crib Specimen temperatures. Temperatures vs. time
Thermocouples located where the crib was positioned on the deck

Specimen temperature data is provided in A 5.2 in Appendix 5.

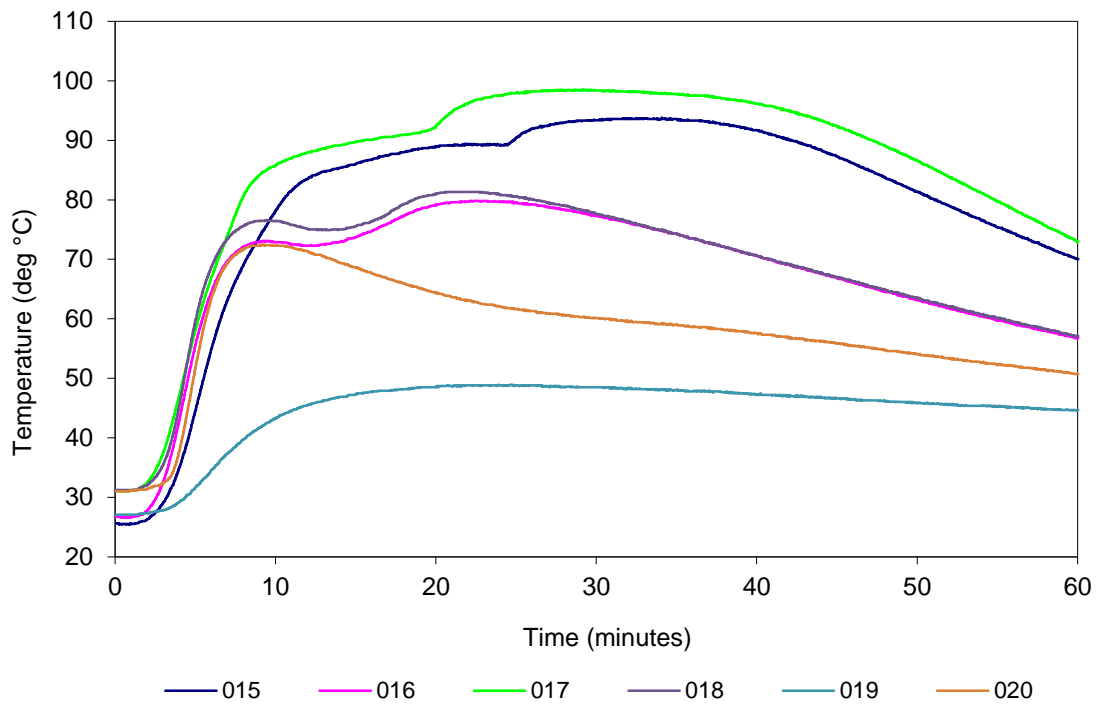
Figure A5.3: Bottom Crib Specimen temperatures. Temperatures vs. time
Thermocouples located where the crib was positioned under the deck

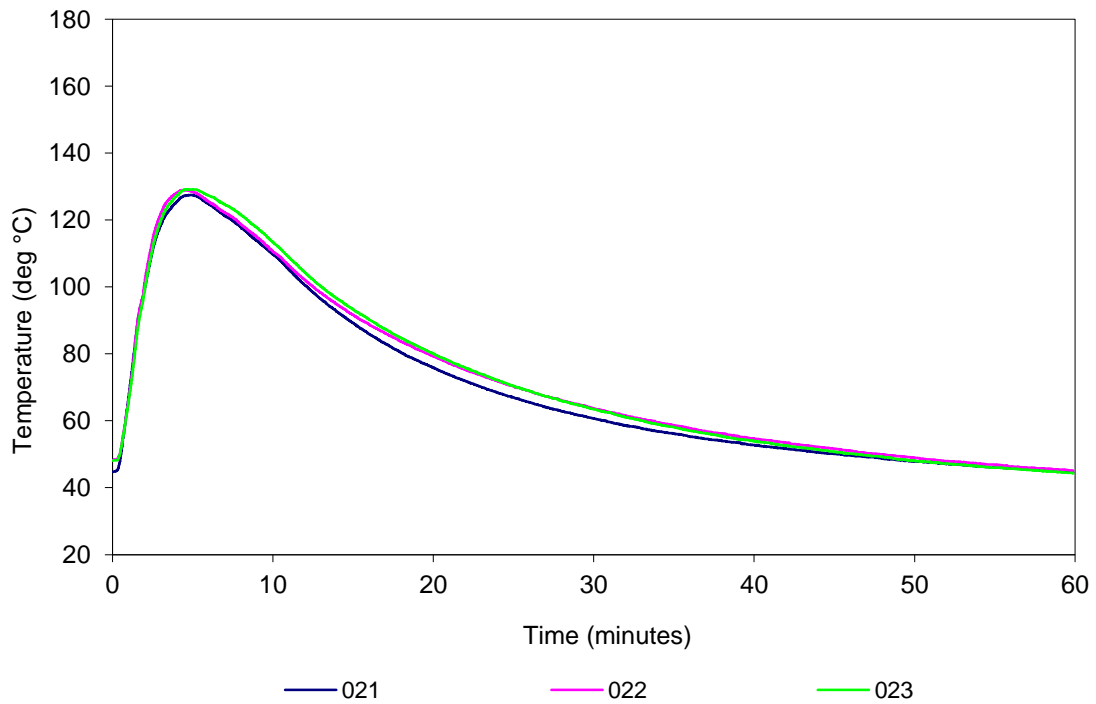
Figure A5.4: Eaves temperatures. Temperatures vs. time

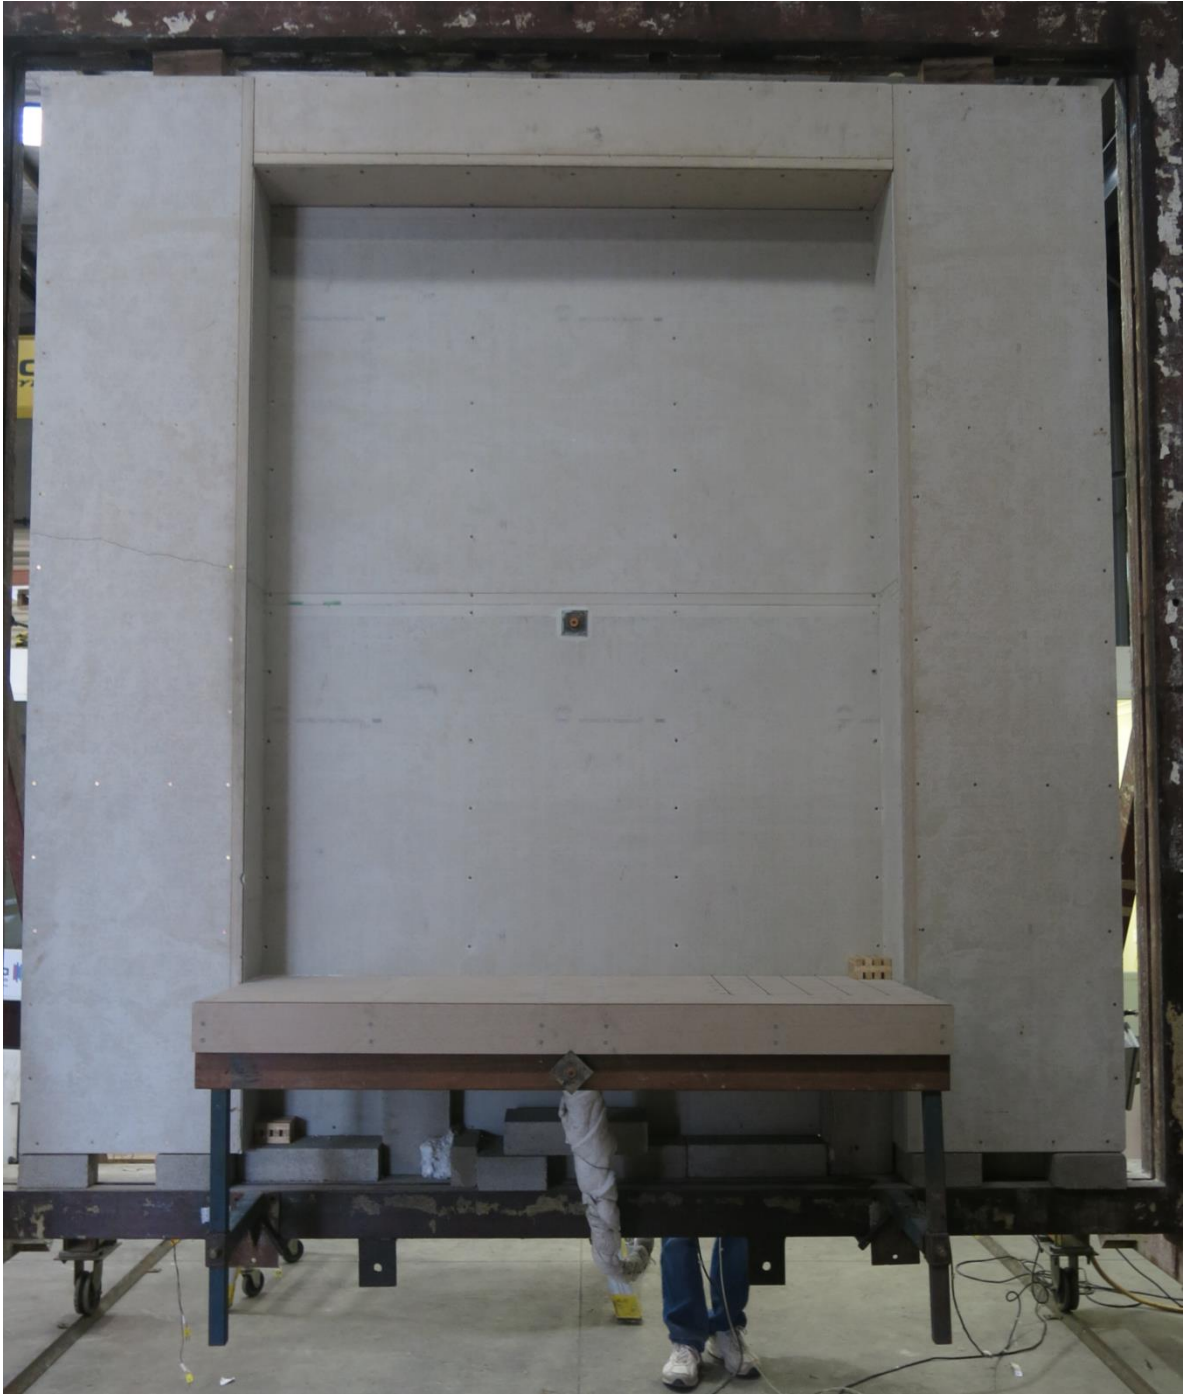
Figure A6.1: Exposed face of specimen before commencement of the test

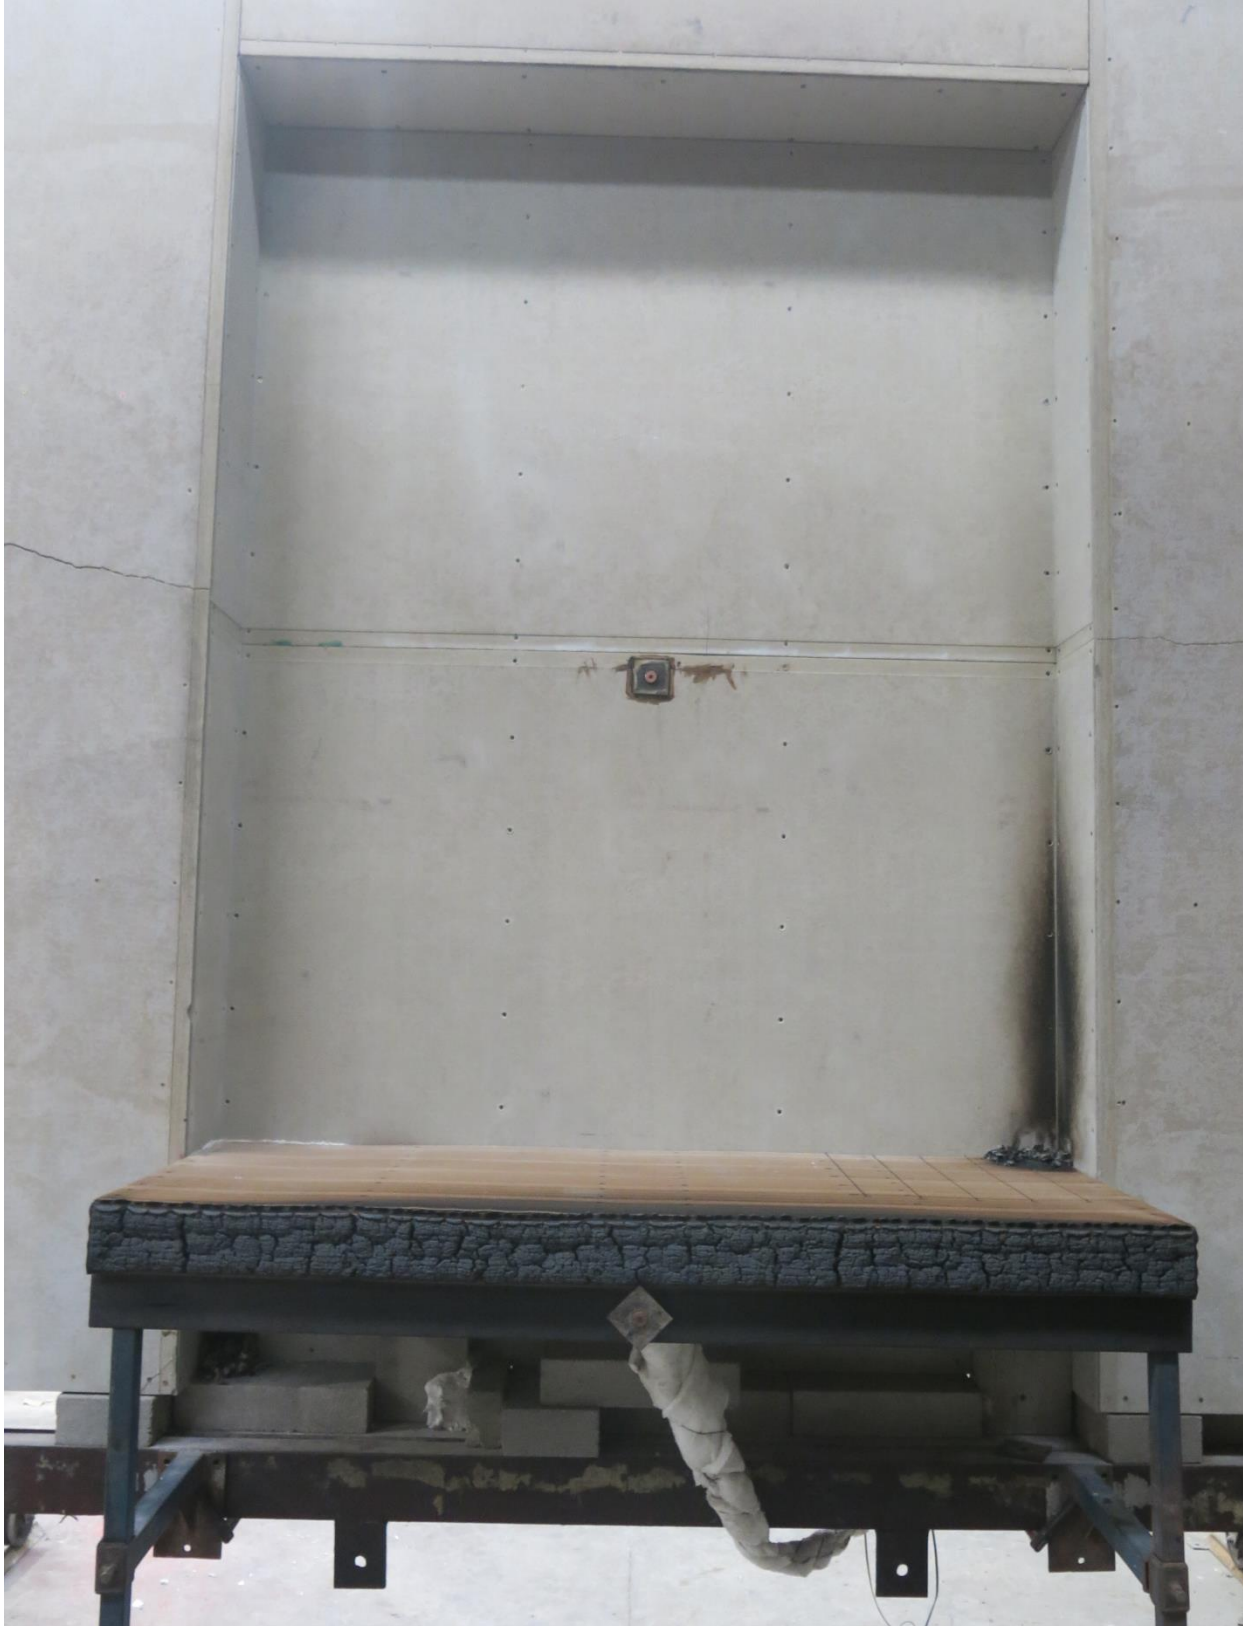
Figure A6.2: Exposed face of specimen at the end of the test.

| Performance Criteria | | Time to Failure (min.) | Position of Failure |
|---|---|---|---|
| Test Result | | BAL A40 | |
